**HUMER KWER HEALTH CENTER
SULAYMANIYAH, IRAQ**

SUSTAINMENT ASSESSMENT

**SIGIR PA-09-186
APRIL 20, 2010**

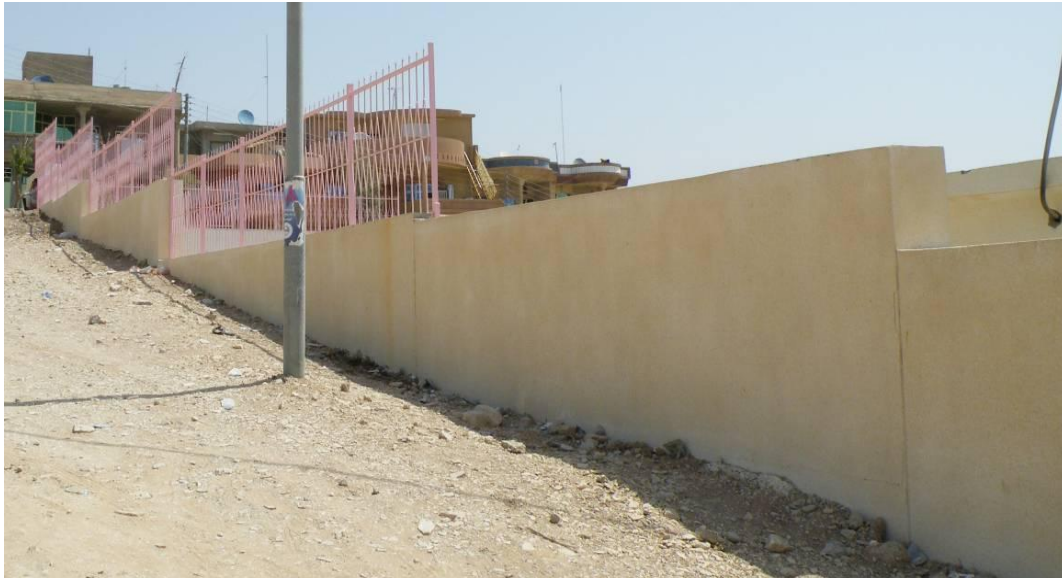
Site Photo 5. Security fence atop perimeter wall

(Site Photo 5). The security wall appeared to be constructed plumb and level, and was stepped to accommodate the steep grade. The wall appeared sound with no apparent cracking or settlement. Three entry points to the facility were constructed with locking steel gates placed at each opening.

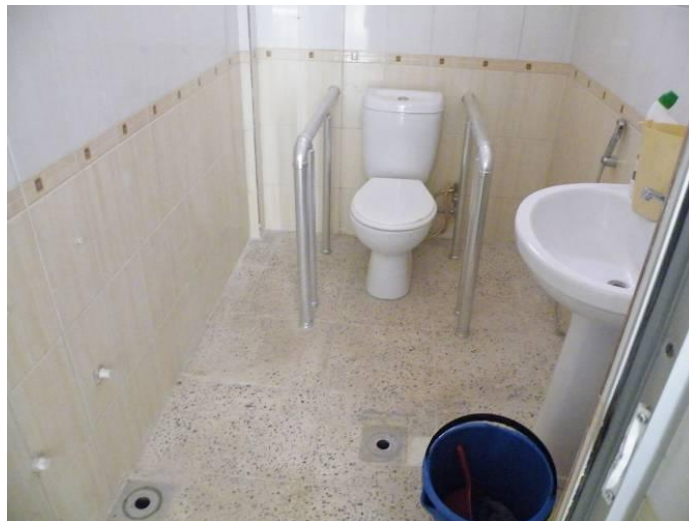
Site Photo 10. Accessible restroom

The upper level contained both conventional and physically-challenged accessible restrooms. The restrooms' construction quality appeared good with no cracked, loose, or missing tile (Site Photo 10). All fixtures and grab bars were firmly attached to the structure. At the time of the site assessment, the restrooms were functioning and relatively clean.

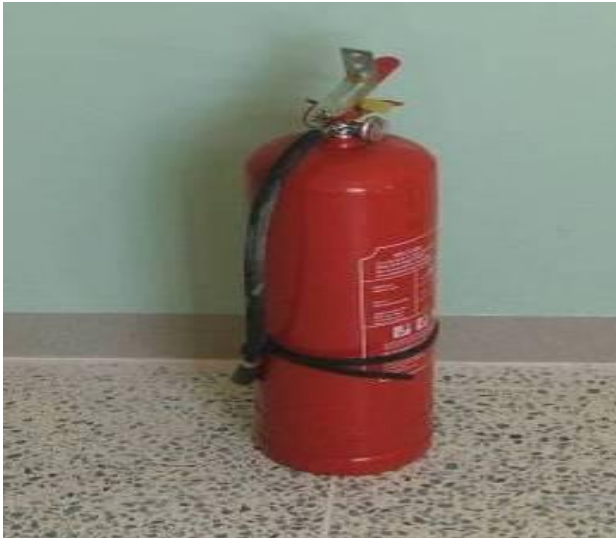
Site Photo 11. Fire extinguisher on main hallway floor

Fire extinguishers were placed on the floor in several areas throughout the building in common hallways and they could easily be kicked or tripped over (Site Photo 11).

1. Install handrails on the staircase.
2. Secure the fire extinguishers and the pressurized gas cylinder.
3. Fix the leaking fuel tank.

Response: Concur. The Gulf Region District Resident Office that executed the project reported that the fuel leak was repaired after SIGIR identified the leak during its site visit in August 2009. After SIGIR issued the Humer Kwer Health Center draft report, the Resident Office contacted the contractor and informed him of the additional deficiencies. The contractor agreed to install the hand rails and secure the fire extinguishers and pressurized gas cylinder. The Resident Office reported those deficiencies should be addressed by 16 April 2010.

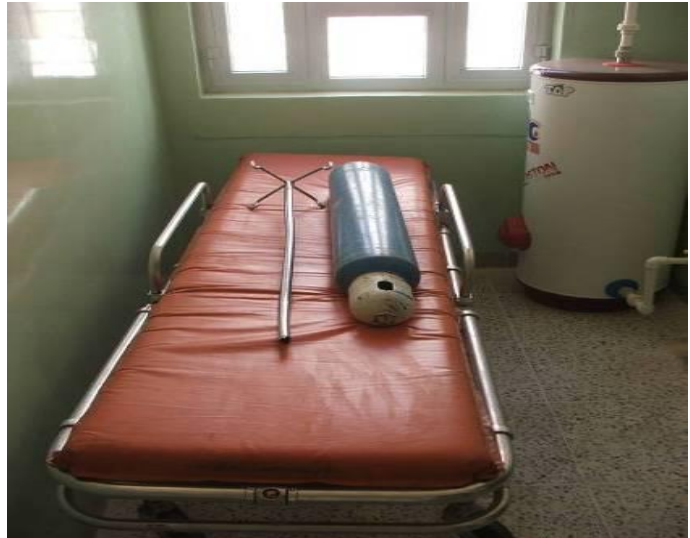
Site Photo 12. Accessible pressurized gas cylinder storage

The SIGIR inspection team noted that a pressurized gas cylinder was on a gurney in one of the hallways (Site Photo 12). The cylinder was accessible to the public and was susceptible to tampering. Pressurized gas cylinders should be secured to prevent accidents.

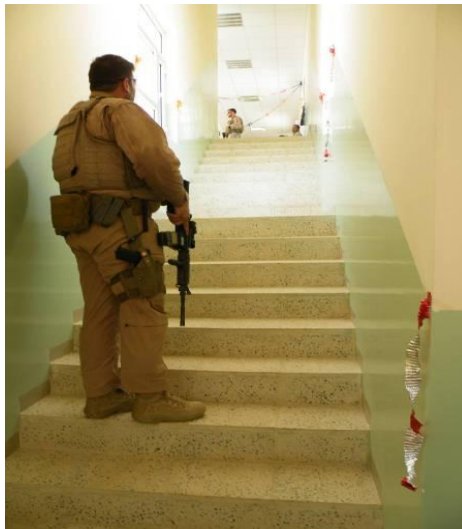
Site Photo 13. Interior stairs connecting upper and lower levels

The contractor constructed reinforced concrete stairs to connect the upper and lower levels (Site Photo 13). The steps appeared to be level and even with consistent risers and tread widths. No apparent cracks or signs of settlement or distress were observed. Handrails were not present in the stairway. Handrails could prevent injury in the event of individuals tripping or losing their footing on the steps.

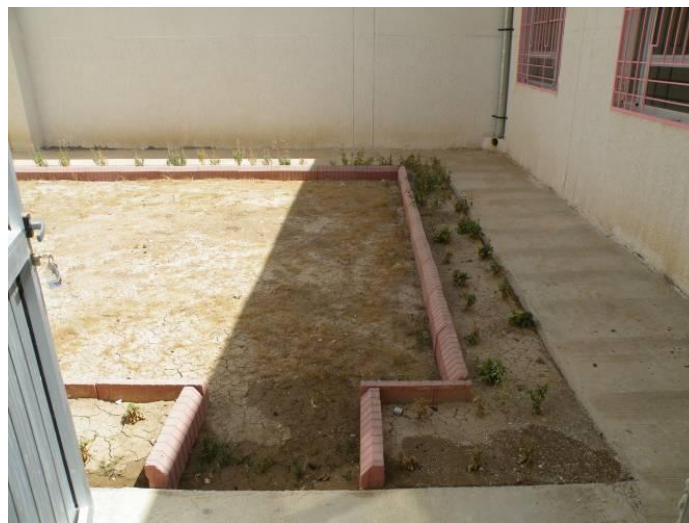
Site Photo 15. Interior courtyard

The geometry of the facility created a small outside area at the elevation of the lower level that was made into a courtyard and contained a perimeter sidewalk with interior plantings. Runoff from a portion of the roof was discharged into the interior plantings to promote plant growth and groundwater recharge (Site Photo 15).

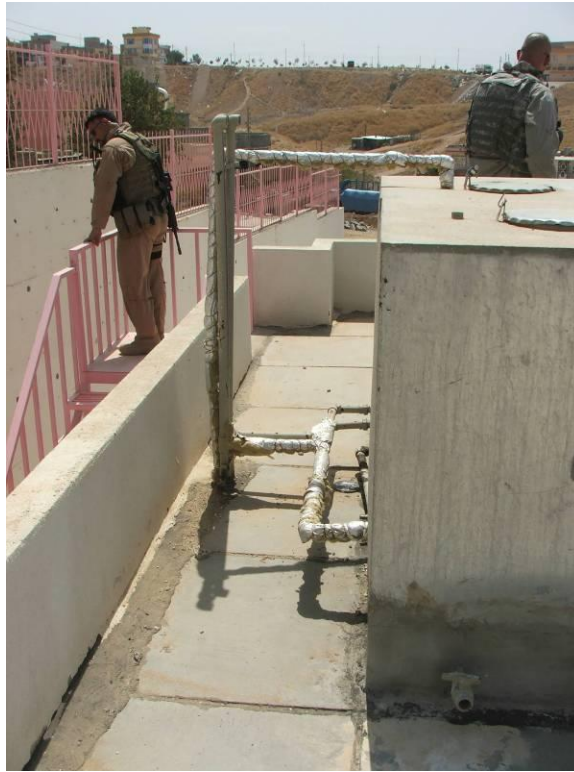
Site Photo 16. Roof tank and piping

The storage tanks appear relatively small compared to the size of the facility. SIGIR inspection teams have reviewed other Iraqi primary healthcare centers with significantly larger potable water storage tanks. Since usage requirements were not provided and the exact amount of potable water available from the municipal system was not provided, the adequacy of the potable water storage could not be determined.

Piping to the tanks appeared to consist of PVC with fiberglass insulating wrap. A GRN KAO representative informed SIGIR that the winter temperatures can fall below freezing, and bursting pipes was an issue on other projects in the region. The insulation on the pipes will provide some measure of protection against freezing. However, since the tank is not insulated, freezing could occur near the various apertures and cause pipe breakage at the tank/pipe interface.

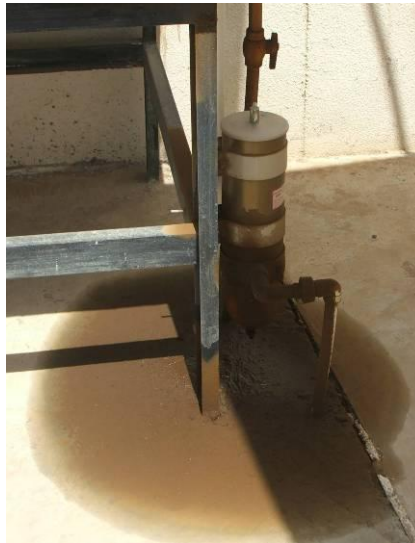
Site Photo 17. Fuel leak at the side of tank

SIGIR noted that the fuel tank was leaking in two locations (Site Photo 17). Due to the limited time on site, the source of the leak could not be determined. However, if the leaks are not repaired, the leaks could present a fire hazard.
